# NON CONFORMITY REPORT

## PLATE HOTEL - 8

| <b>Code:</b> | Non Conformity Report_PLATE HOTEL - 8 |

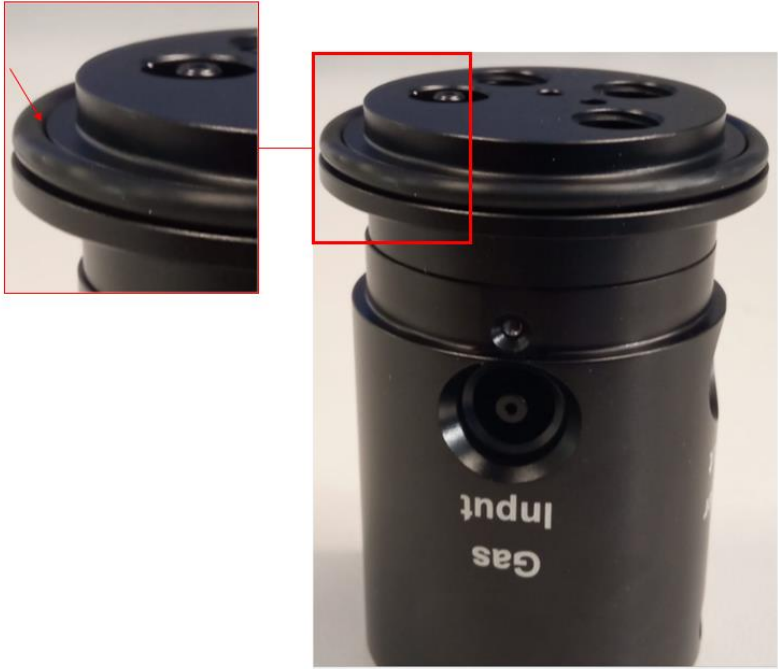
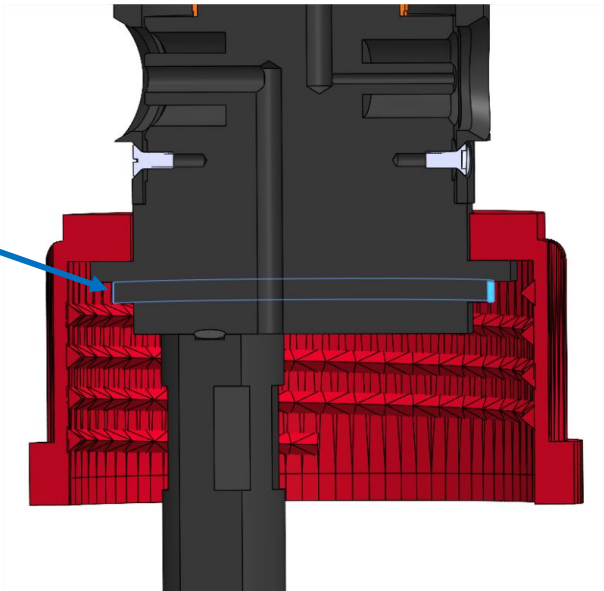
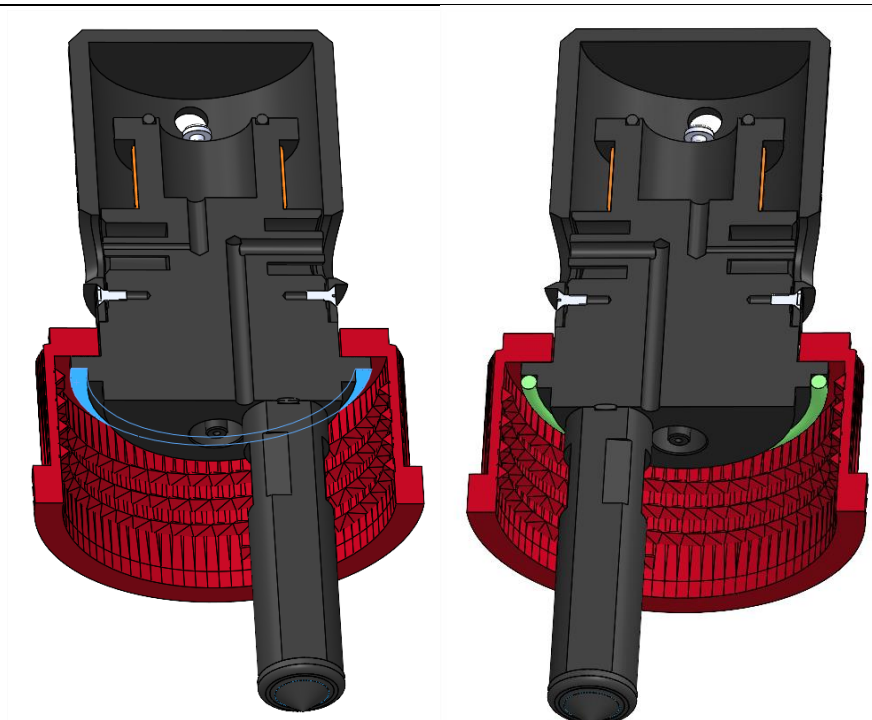
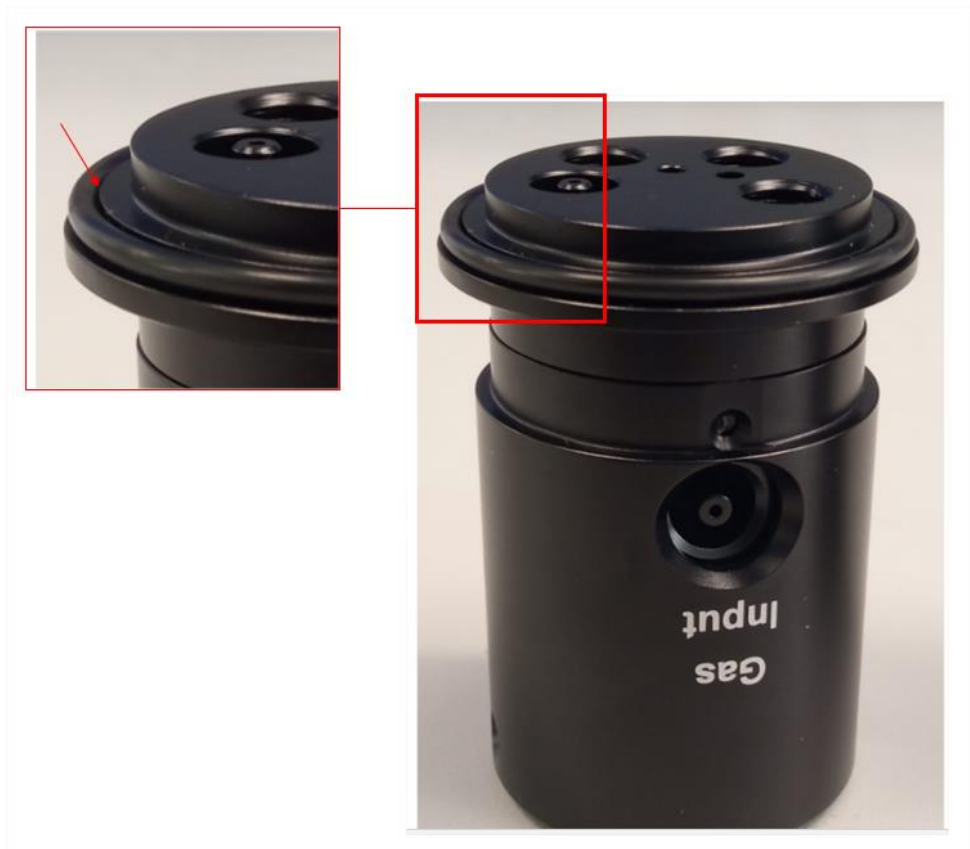
| NC #1 - Summary | | | |
|---|---|---|---|
| Description of the NC | The customer contacted us reporting that there is no airflow coming out of the humidifier cap when the cap is fully screwed on. If it is unscrewed slightly, airflow can be seen.<br>Video is attached to clarify the issue. | | |

| <p><b>Root Cause Analysis</b></p> | <p>The refill cap has an O-ring with a thickness of 2 mm, which sits inside a 2 mm deep groove. The figure highlights the groove, which is 2 mm, where the O-ring should be placed.</p> <p>In details:</p> <ul style="list-style-type: none"> <li>- In blue the surface where the O-ring is placed</li> <li>- In green the O-ring</li> </ul> |

When the O-ring is installed, it is positioned below the highlighted surface in the figure above. Therefore, when the cap is screwed on, the O-ring may be not compressed, but instead, contact is made with the metal surface, which causes a leak.

| NC #1 - Summary | | | |
|---|---|---|---|
| Containement Actions | New selected O-ring: is OR-34X2.20-NBR70<br>It protrudes slightly in relation to the metal surface and therefore when closing the cap, it is closed with the O-ring and thus a seal is ensured. | | |

| Corrective Actions | No | Identified Action | Responsible | Target Date |
|---|---|---|---|---|
| | 1 | Mechanical reworking of the O-ring housing metal part | Ranesh Thanikasalam | To be defined |

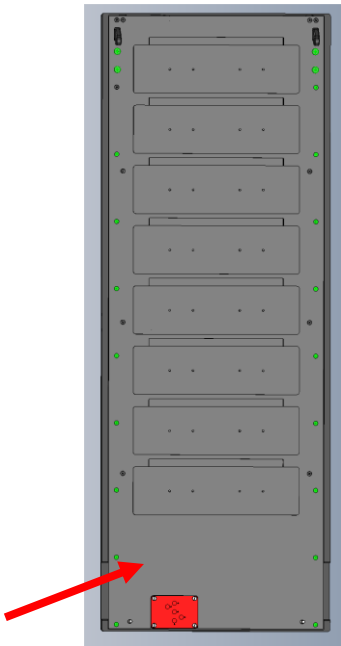
| NC #2 - Summary | | | |
|---|---|---|---|
| Description of the NC | <p>The customer contacted us reporting that the screws (highlighted in green) of the front door came loose and detached from their housing.</p> <p>When the door was sent for RMA to replace these screws, it was noticed that:</p> <ol style="list-style-type: none"> <li>1. The screws cannot be fully screwed in because this deforms the sheet metal (indicated by the red arrow), creating an air gap and thus a leakage of approximately 0.7 l/min, which causes the quality tests to fail.</li> </ol> | | |

| <b>Root Cause Analysis</b> | The sheet metal is very large and thin. If the screws are overtightened, the sheet metal tends to deform and makes contact with the overhead doors, which tend to open and create a small gap. | | | |

| <b>Containement Actions</b> | Tighten the fastening screws and then secure them with threadlocker to prevent sheet metal deformation. | | | |

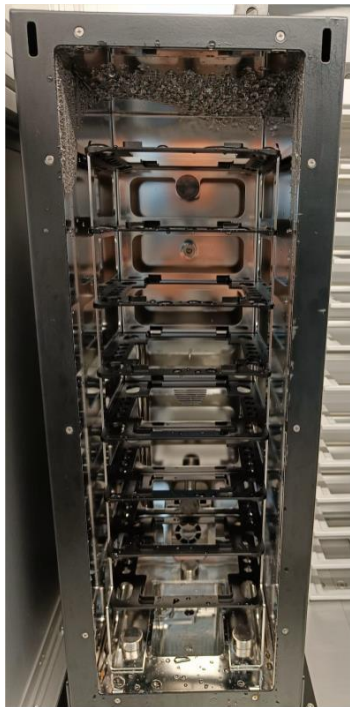
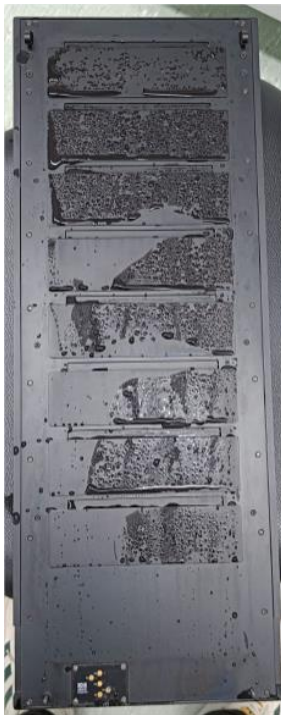
| NC #1 - Summary | | | |
|---|---|---|---|
| Description of the NC | The customer has contacted Customer Care because a lot of condensation has been found inside the PLATE HOTEL 1008, after shutdowns and switch-on of the entire system (PLATE HOTEL + VIVACYTE) due to a software update. | | |
| | The condensation observed is a consequence of the MKH being shut down without the internal tank emptying first. Consequently, the water drops affected the humidity sensor, which did not show any reading ( <b>Humidity: ...</b> ), <b>Humidity Status: "Error"</b> and a <b>Humidity</b> | | |

| | <b>sensor temperature of "-104.00"</b> , means that the reading temperature of the humidity sensor is OUT OF RANGE [0.0 80.0] °C. | | | |

| Containement Actions | A new software version can be developed and installed on all PLATE-HOTEL-8 where the heating elements are always on, even when the system is in "Stand-by" mode. The selective heating of the inner walls can reduce the condensation even if a power loss event happens. | | | |

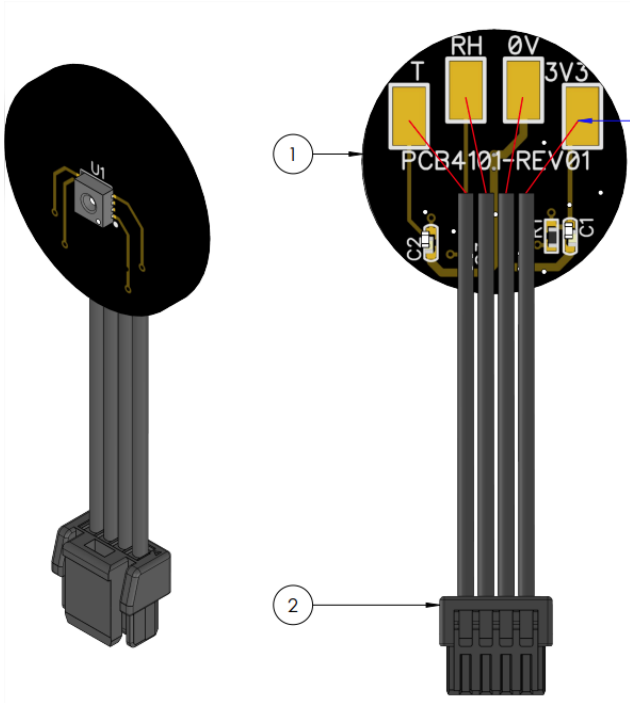
| Root Cause Analysis | <p>The Humidity sensor is not responding as expected. As reported on the datasheet, the Humidity sensor can withstand water drops. The wrong reading is due to a high amount of water on the PCB where the sensor is placed and the absence of a protective coating for the exposed copper pads.</p> <p>Therefore, the root causes of the Humidity Sensor's damage are:</p> <ul style="list-style-type: none"> <li>- the MKH shutdown without emptying the internal tank first.</li> </ul> | | | |

| | 5 | The PLATE-HOTEL-8 firmware can be modified to read the humidity at start and if it is higher than a threshold the heaters will stay on, even in Stand-by mode = 1. This may reduce condensation and in turn prevent further damage. | Giulio Pasquariello | TBD |

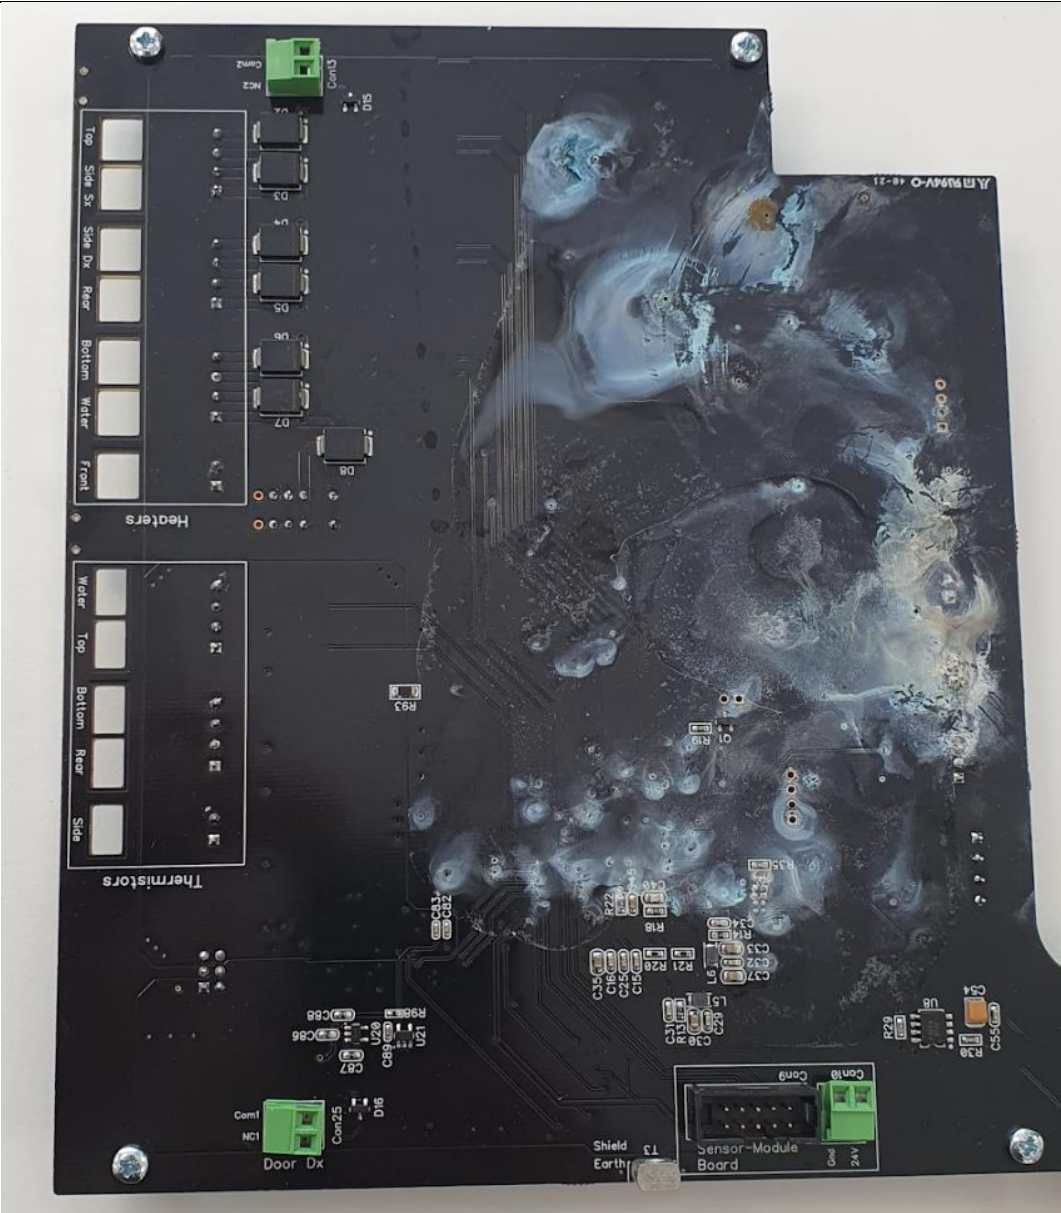
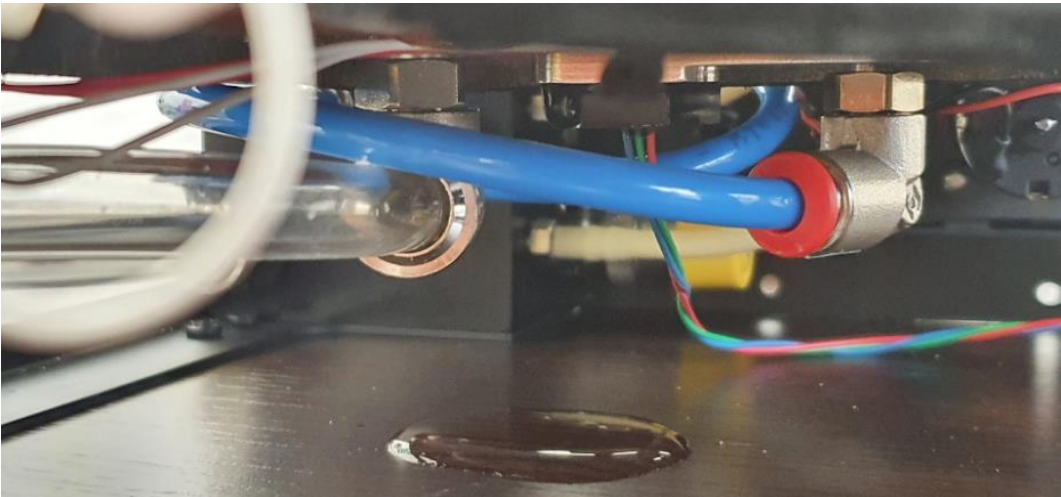
| NC #1 - Summary | | | |
|---|---|---|---|
| Description of the NC | The MULTI KIT HOTEL is not recognize by the PC. | | |
| Root Cause Analysis | Root Cause: The MULTI KIT HOTEL is not recognize by the PC. This is because the PCB card has been damaged due to a water leak. | | |

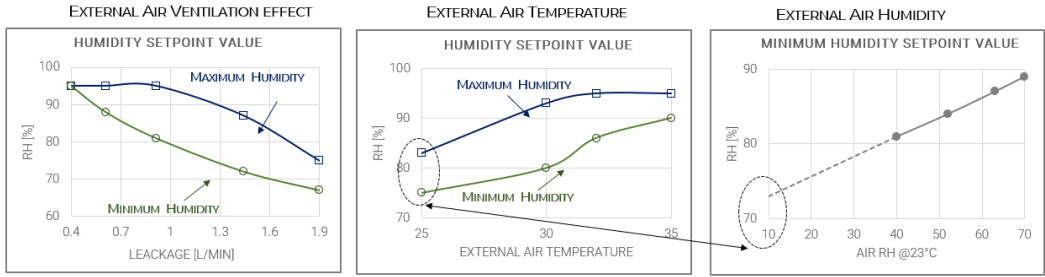
| NC #2 - Summary | | | |
|---|---|---|---|
| Description of the NC | <p>The humidity setpoint value of 90% is not reached.</p> <p>The three graphs illustrate the relationship between humidity setpoint value and various factors. The first graph, 'EXTERNAL AIR VENTILATION EFFECT', shows RH [%] vs LEAKAGE [L/MIN] with a blue line for 'MAXIMUM HUMIDITY' and a green line for 'MINIMUM HUMIDITY'. The second graph, 'EXTERNAL AIR TEMPERATURE', shows RH [%] vs EXTERNAL AIR TEMPERATURE with similar blue and green lines. The third graph, 'EXTERNAL AIR HUMIDITY', shows RH [%] vs AIR RH @23°C with a single line. Dashed circles in the second and third graphs indicate a specific data point where RH is approximately 70% at 25°C and 10% RH @23°C.</p> | | |

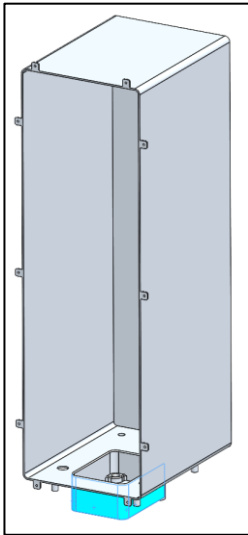
| NC #2 - Summary | | | |
|---|---|---|---|
| Root Cause Analysis | <p>Root Cause: since the water tank is directly connected to the main body of the internal steel structure, a fraction of the heat needed to warm up the water and generate humidity spreads to the whole structure, therefore the humidity setpoint value of 90% is not hit.</p> <p>The 3D CAD model shows a water tank assembly with a blue base and a grey main body. The tank is connected to a main body of the internal steel structure, which is highlighted in blue.</p> | | |

| Corrective Actions | No | Identified Action | Responsible | Target Date |
|---|---|---|---|---|
| | 1 | Increase the power of the heating resistance placed under the water tank. | Marco Adinolfi | 16/02/2024 |

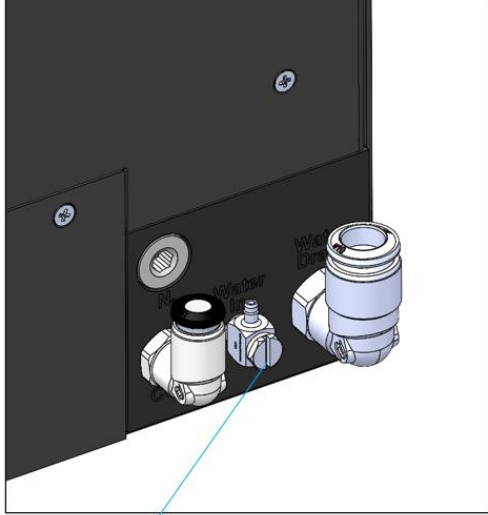
| NC #3 - Summary | | | |
|---|---|---|---|
| Description of the NC | <p>The silicone tube can be easily detached from current water inlet connector.</p> <p>Water connector</p> | | |
| Root Cause Analysis | <p>Root Cause: the inner diameter of the silicone tube is 3mm while the water inlet connector diameter is 3.2 mm. Because of this, the silicone tube can be easily detached.</p> | | |

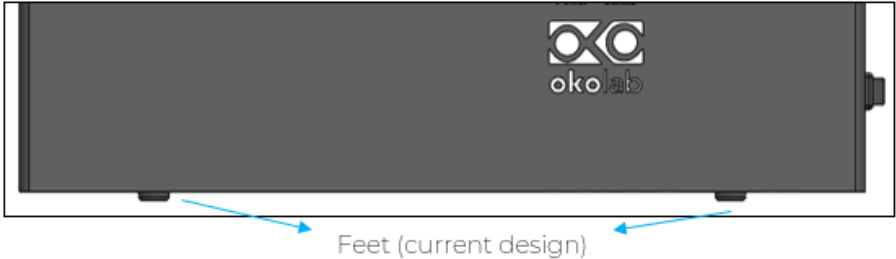
| NC #4 - Summary | | | | |
|---|---|---|---|---|
| Description of the NC | <p>Current non-slip feet are damaged when the plate hotel is moved onto the surface without being lifted.</p> | | | |
| Root Cause Analysis | Root Cause: the feet are not adequate for the mass of MKH. | | | |

| NC #4 - Summary | | | | |
|---|---|---|---|---|
| | 1 | Feet have been replaced with 126-4923, by rs. | Marco Adinolfi | 16/02/2024 |

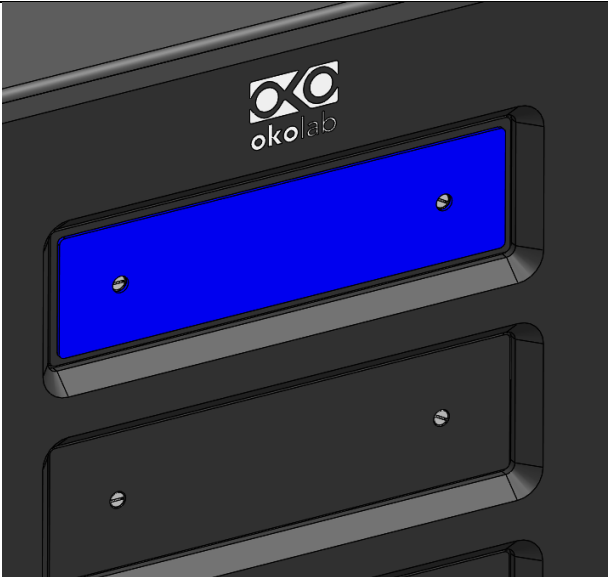
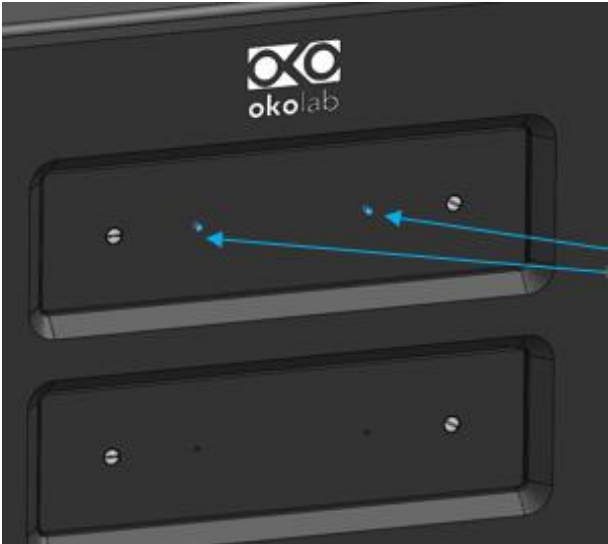
| NC #5 - Summary | | | | |
|---|---|---|---|---|
| Description of the NC | All frontal doors are made by black anodized aluminium. Scratches on frontal doors due to the arm entering the plate hotel. | | | |
| Root Cause Analysis | Root Cause: Since frontal doors are made by black anodized aluminum, they are easily scratched by the arm entering the plate hotel. | | | |

| NC #5 - Summary | | | | |
|---|---|---|---|---|
| | 1 | Apply anti-scratches adhesive tape on each door (blue highlighted) in order to protect the doors. | Marco Adinolfi | 16/02/2024 |

| | | <p>Material: tape</p> <p>Surface finishing: smooth</p> <p>Color: black</p> <p>Two threaded holes will be added on the door to eventually screw in a plastic sheet.</p> | | |

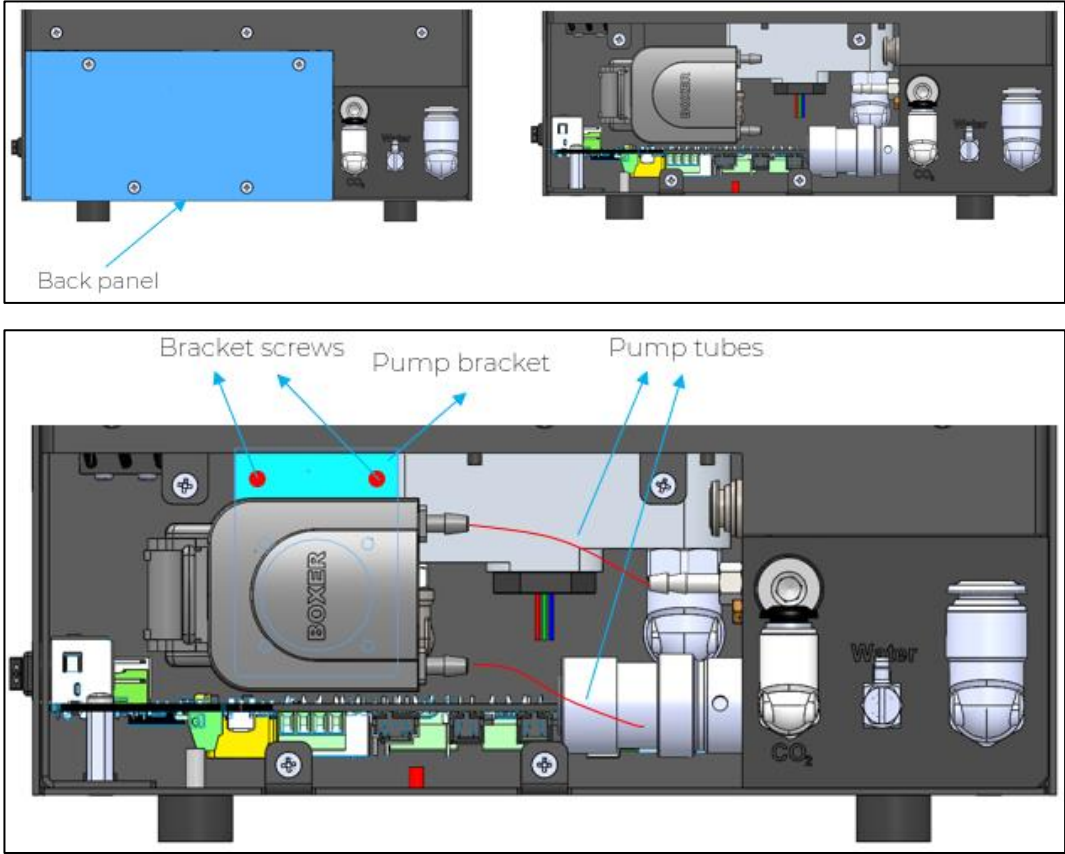
| NC #6 - Summary | | | |
|---|---|---|---|
| Description of the NC | <p>The pump is mounted inside the plate hotel. It is not possible to substitute the pump for the customer because of limited access to the pump fixings. The bracket of the pump is part of the internal frame.</p> | | |

| <b>Root Cause Analysis</b> | Root Cause: access to the pump fixings is quite limited and this makes pump replacement very hard for the customer. | | | |

| | 1 | <p>The steps to substitute the pump become:</p> <ol style="list-style-type: none"> <li>1. Unscrew and remove back panel</li> <li>2. Detach the two pump tubes</li> <li>3. Unscrew pump bracket</li> <li>4. Detach pump connector and remove pump</li> <li>5. Connect new pump connector</li> <li>6. Screw the pump bracket</li> <li>7. Connect the two pump tubes</li> <li>8. Screw the back panel</li> </ol> <p>The substitution would be easy without charging on production costs</p> <p>Pump is still inside the PLATE-HOTEL chassis.</p> | Marco Adinolfi | 16/02/2024 |

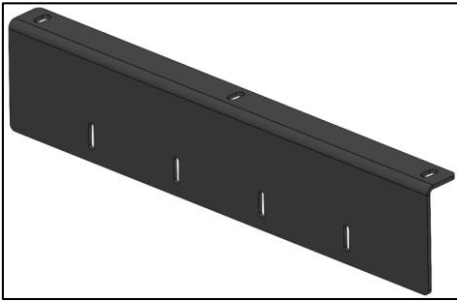
| NC #7 - Summary | | | | |
|---|---|---|---|---|
| Description of the NC | Current brackets design is not compatible with CELLPLY application; therefore, they could not use them. | | | |
| Root Cause Analysis | Root Cause: CELLPLY application is characterized by a different fixing pattern than the one used in OKOLAB current bracket design. | | | |

| NC #7 - Summary | | | | |
|---|---|---|---|---|
| | 1 | <p>The design is updated following the model send by the customer.</p> | Marco Adinolfi | 16/02/2024 |

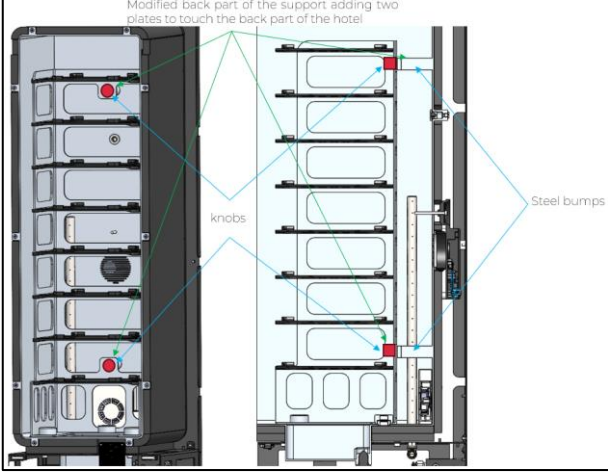
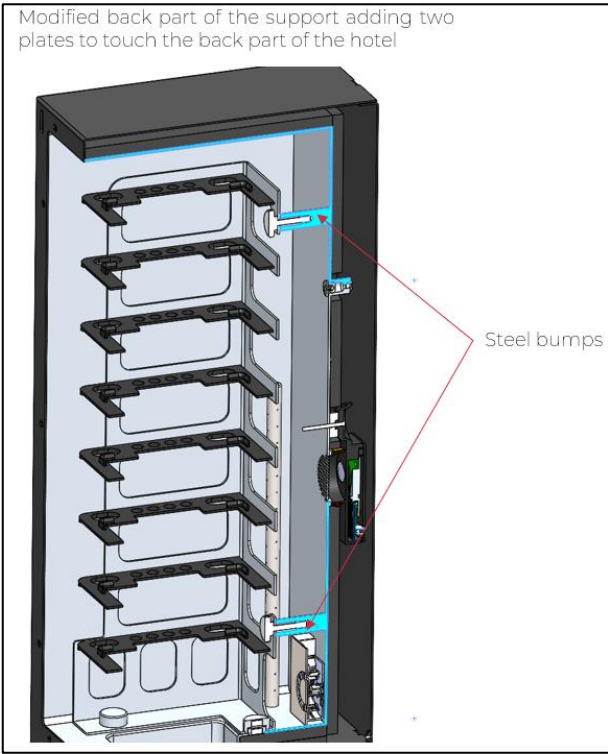
| NC #8 - Summary | | | | |
|---|---|---|---|---|
| Description of the NC | The mounting bracket touches the walls on x direction and has a rotation on y direction due to the support positioning. Because of that, support internal position is not repeatable. | | | |

| NC #8 - Summary | | | | |
|---|---|---|---|---|
| | 1 | Add two steel bumps on the back part of the hotel and two plates on the support working as hard stopping. Mounting bracket back surface and steel bumps will be in contact. Furthermore, two knobs (red highlighted) are added to screw the mounting bracket to steel bumps and fix the bracket to the hotel. | Marco Adinolfi | 16/02/2024 |

| | <div><p>Modified back part of the support adding two plates to touch the back part of the hotel</p></div> <div><p>Modified back part of the support adding two plates to touch the back part of the hotel</p></div> | | |

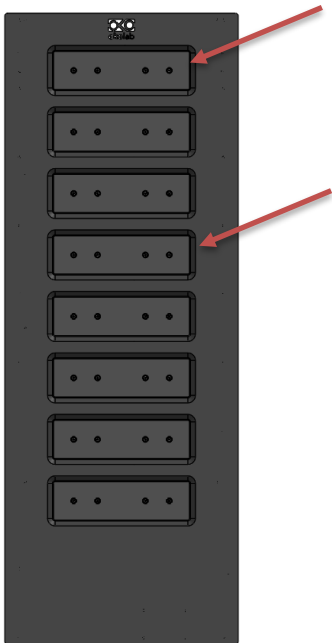
| NC #10 - Summary | | | |
|---|---|---|---|
| Description of the NC | <p>The highlighted doors of the MULTI KIT HOTEL cannot be properly closed.</p> | | |

| <b>Containement Actions</b> | <i>Rework of the affected components in order to let the doors be properly closed.</i> | | | |

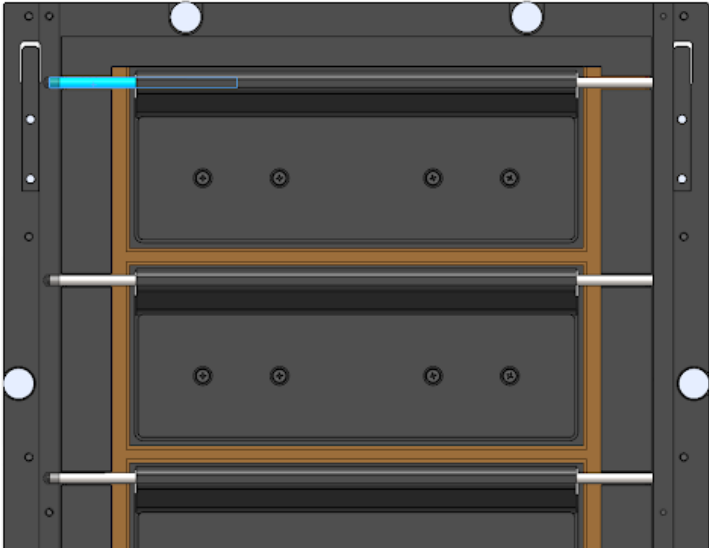
| <b>Root Cause Analysis</b> | <p>The root cause has been identified in the disalignment of the holes that prevents the linearity of the door's hinge, affecting its closure.</p> | | | |

| | 1 | Adding in the 3D drawing a disclaimer with the aim of letting the supplier pay attention during the production steps of aforementioned holes. | Marco Adinolfi | 07/03/2024 |

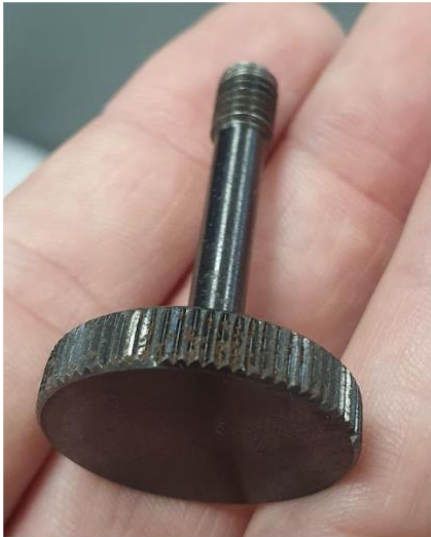
| NC #11 - Summary | | | |
|---|---|---|---|
| <b>Description of the NC</b> | <p>The material of the two knobs used to secure the internal shelves to the PLATE-HOTEL-8 body has been wrongly selected because currently, it is burnished steel instead of inox steel. As shown in the picture below, burnished steel will rust in a humid environment.</p> | | |

| Root Cause Analysis | The R&D Designer wrongly selected the material for the knobs. | | | |
