# NON CONFORMITY REPORT

H401-230x110-GLASS-PLATE

| <b>Code:</b> | Non Conformity Report_ H401-230x110-GLASS-PLATE |

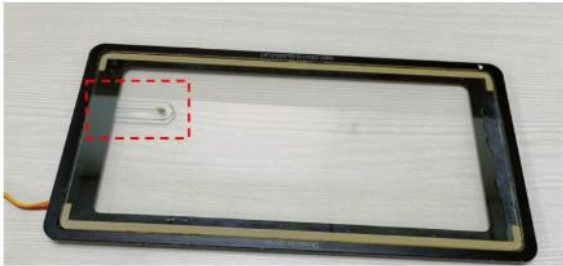
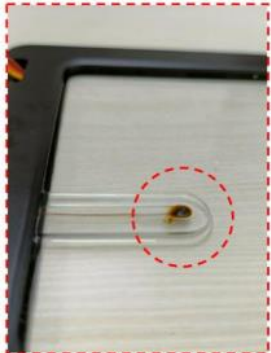
| NC #2 - Summary | | | |
|---|---|---|---|
| Description of the NC | <p>During the normal working of the thermal plate, start to appear breakage of the bus bars on the top side of the glass.</p> <div></div> | | |
| Root Cause Analysis | <p>The thermistor has burned due to a connection of 24V to the thermistor circuit.</p> <p>The non conformity could be associated either to a PCB electronic schematics issue, or something related to liquid infiltrations on the contact placed on the PCB.</p> <p><u>A further investigation must be done to understand clearly the root cause of the non conformity.</u></p> | | |

| NC #2 - Summary | | | |
|---|---|---|---|
| Containement Actions | Return to the factory of the affected serial number and replacement with a brand new one. | | |

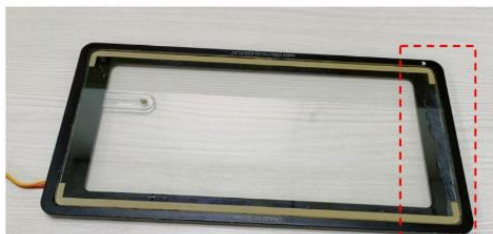
| NC #1 - Summary | | | | |
|---|---|---|---|---|
| Description of the NC | <p>Presence of stain and damage in correspondence of the bottom side of the heated glass. The thermal plate doesn't heat correctly and doesn't reach the thermal uniformity.</p> <div></div> | | | |
| Root Cause Analysis | Root Cause: The breakage is caused by liquid infiltrations on the gap between the glass and the metal frame. The external board of the glass is not isolated. | | | |

| NC #1 - Summary | | | | |
|---|---|---|---|---|
| | 1 | PRODUCT REVISION: Realize a sealing gasket all around the glass, from top that protects the | Ranesh Thanikasalam | 30/10/2023 |

| | bus bars from liquid infiltrations. The aluminium frame shall be modified in order to realize a 0.50 mm gap all around the glass, to be covered with the sealant, to avoid liquid contact with the conductive bus bars and near conductive points that may create damages. | | |

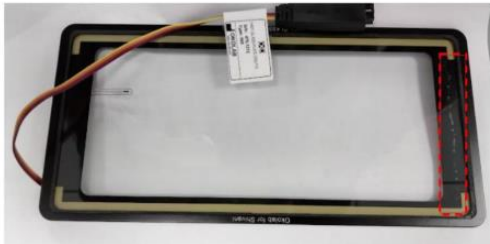
| NC #3 - Summary | | | |
|---|---|---|---|
| Description of the NC | <p>The thermal plates have aesthetically defect on the black inked mark on the heated glass.</p> <div> </div> | | |

| <b>Root Cause Analysis</b> | Root Cause: The heated glass is glued on a bottom PCB by using epoxy adhesive. The esthetic defects are generated by a non conform adhesives curing procedure, that has caused the visible detachment of the glass from the bottom PCB. | | | |

| | 1 | Review the adhesive curing procedure, in terms of curing temperature and time in order to avoid the generation of the stains. | <i>Ranesh Thanikasalam</i> | 30/01/2024 |
| | 2 | Add in the production checklist a check that gives instruction to keep the heated plates at stock for one week before shipment, in order to visual check the presence of non-conform stains on the black ink. | <i>Ranesh Thanikasalam</i> | 30/01/2024 |
